**TFTR D&D Project: Final Examination and Testing
of the TFTR TF-Coils**

by
Irving J. Zatz

January 2003

**PRINCETON PLASMA PHYSICS LABORATORY
PRINCETON UNIVERSITY, PRINCETON, NEW JERSEY**

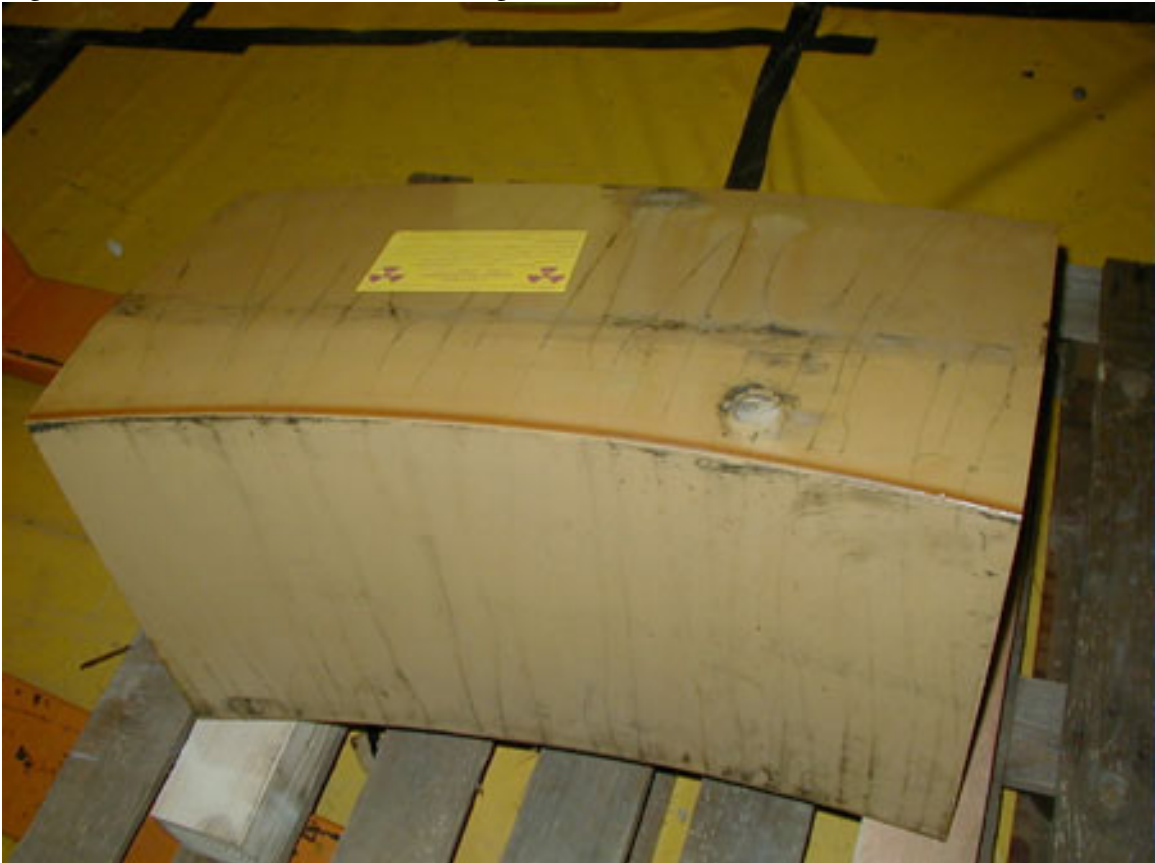
Figure 6 - TF #3 nose section bundle with potting compound intact

Upon closer visual inspection, the coil bundles appeared to be in outstanding condition, showing virtually no observable signs of wear or fatigue. Epoxy and potting compound penetration appeared to be uniformly excellent throughout. No visible voids could be found. It was hard to imagine that a structure this complex could have endured over 100,000 mechanical and thermal load cycles and looked so pristine. When the case components were removed from the coil bundles, concerns about the deterioration of the potting compound on the exterior faces of the coil bundles proved to be unfounded. It had been suspected that with years of load cycling, coil movement within the case could have gradually cracked and ground the potting compound into small pieces or even dust. In fact, in every coil examined, the potting compound was not only found to be intact, but retained an almost Teflon-like quality (Figure 6) enabling the coil to glide in a nearly frictionless manner within the coil case during operations. When the case pieces were first unbolted, these segments, each weighing hundreds of pounds, could be readily slid along the coil's potting compound surface with relative ease (Figure 7). The only signs of wear were superficial cracks along the potting compound surface (Figures 8 & 9). There was no spalling. Black marks found on the surface of the potting compound was determined to be residue of the parting agent (mold release) used to prevent the potting compound from bonding with the case during original impregnation. The same black markings were found on the case pieces as well.

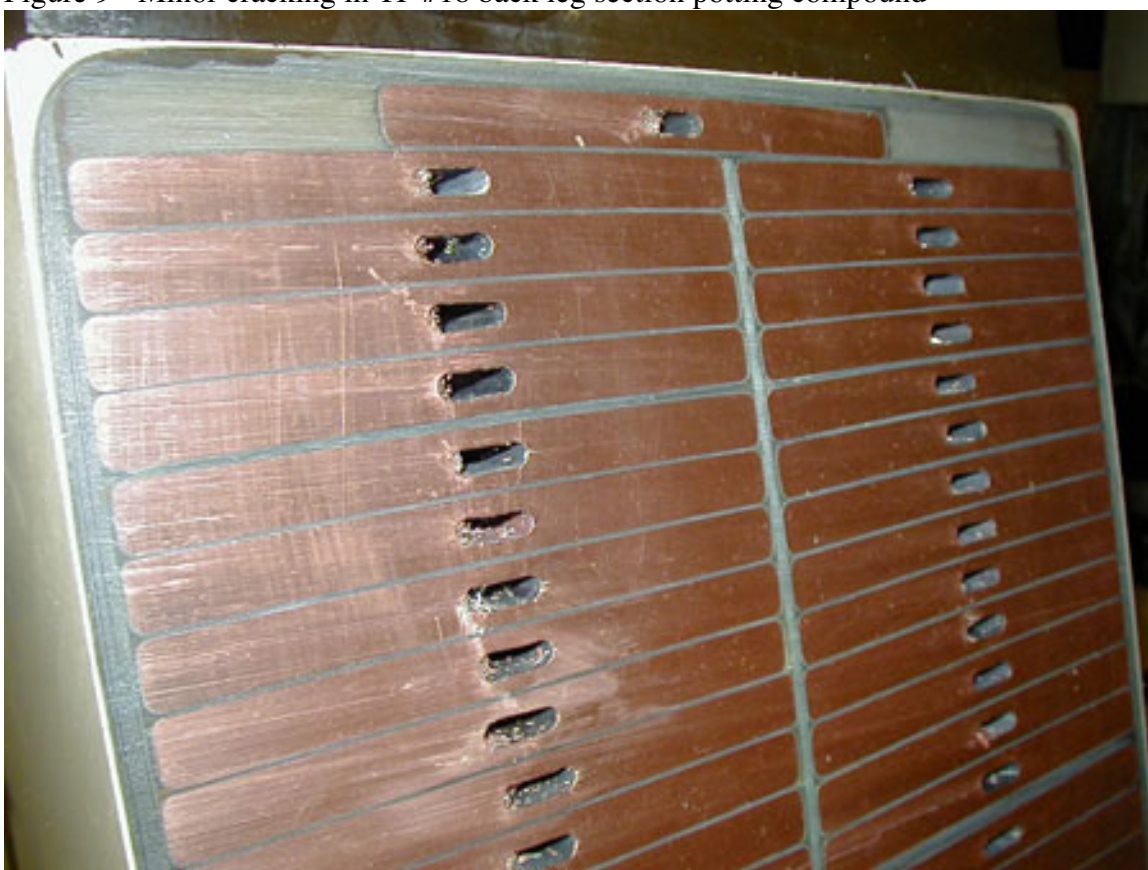
Figure 10 - Close up view of turn transition in back leg of TF #3

These visual inspections of every TF coil cross section found that the coils were built and assembled with remarkable consistency and quality. The extruded cooling channels were clear and clean. Turn transition regions were smooth and consistent (Figure 10). No evidence of any turn-to-turn shorts, burn marks or contact could be found. There were only two observable geometric anomalies. Occasionally, the turns within a 22-turn pancake would not be in perfect alignment and would vary by up to 3 mm (Figures 11 & 12). Also seen in these figures is that the turn-to-turn insulation layer thickness normally varied within a range of twenty percent of the 0.05-inch design thickness, but in no instance was any metal-to-metal contact observed.

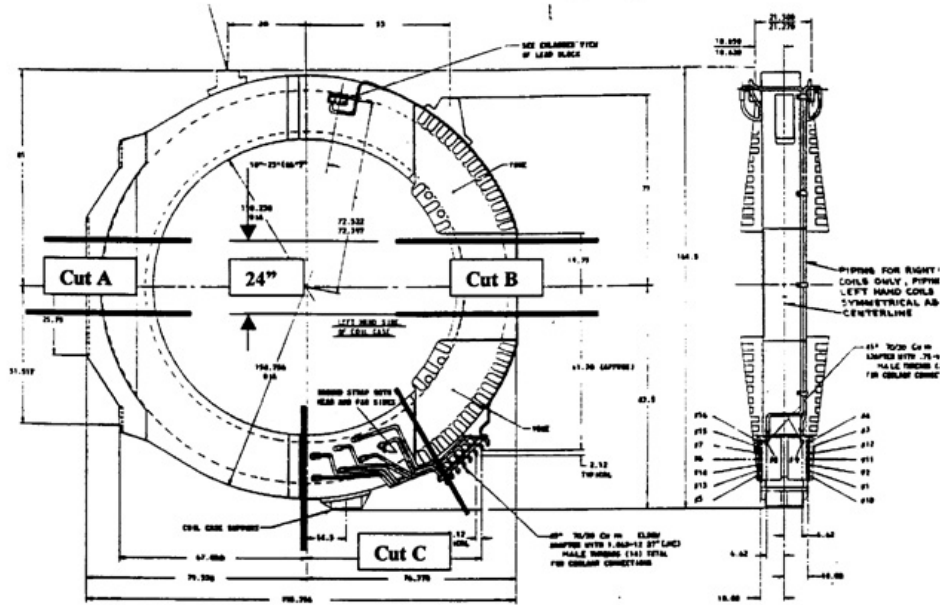
Figure 13 - Cut plan to extract three test sections from TF #3 [Reference 6]

As indicated previously, the baseline test program would take samples from TF coils #3 and #18. Accordingly, these coils were to be cut differently, in accordance with the layouts shown on Figures 13 & 14, respectively [Reference 7]. Three two-to-three-foot long segments would be taken from each of these coils (Figure 15). Segments from the mid-plane inner and outer legs of these two coils would be set aside. TF #3's third segment would be the water-fitting region while TF #18's third segment would be from the lead block region. Six cuts on the Marvel saw were required for each of these coils instead of the usual bisecting two cuts for the other TF coils (Figure 16).

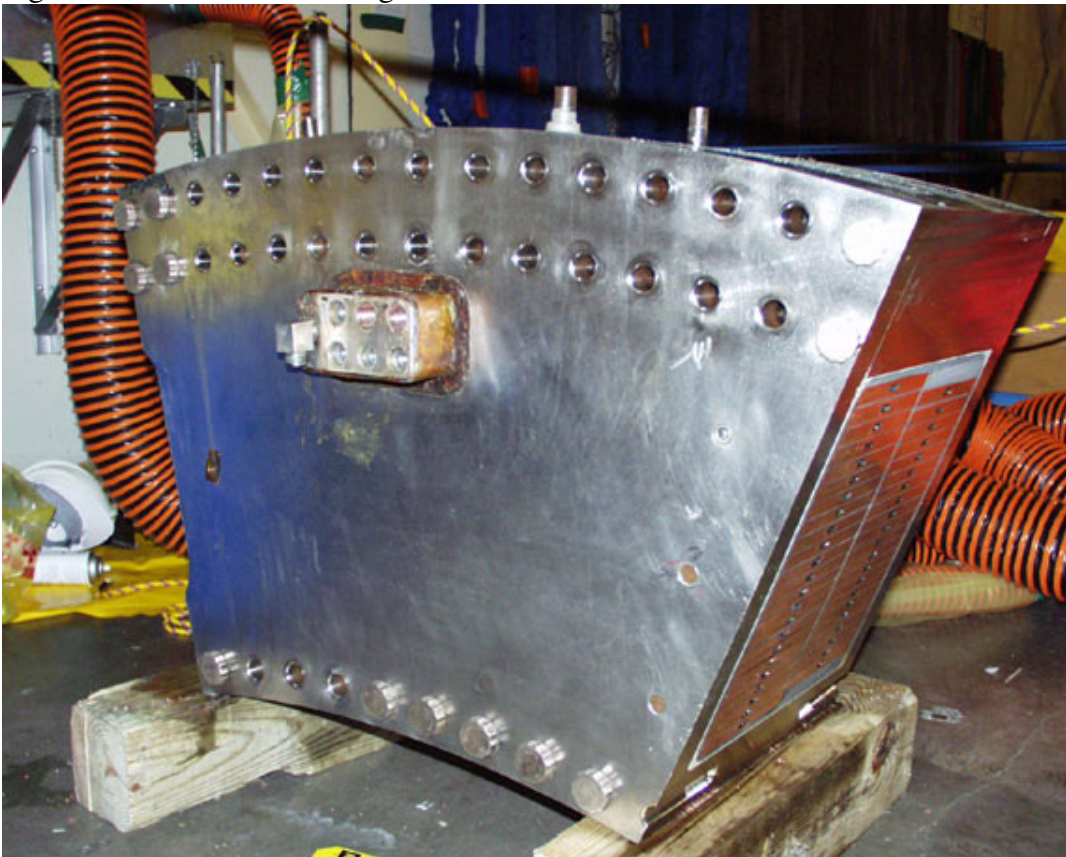
Figure 20 - TF #18 lead block coil section

A chronic leak developed in the lead block region of TF #18 that was speculated to have originated in the lead spur joint within the body of the coil. This leak could not be rectified despite numerous in situ inspections and attempted remedies [example Reference 6].

The TF #18 lead block segment was originally cut in the TFTR Test Cell to preserve both the lead block protruding from the side of the coil as well as the lead spur located within the coil body. Over the years, the lead spur had been identified as the prime candidate for the origin of the chronic leak in TF #18 (Figure 24). While still in the Rad Waste building, the lead area was borescoped from several locations, but the results were inconclusive regarding the origin of the leak. It was originally planned to disassemble this coil section so that the lead block/spur turn could be investigated in detail, however, resources became limited and this exercise could not be completed. The TF #18 lead block coil section remains in the Rad Waste building awaiting the possibility of conducting this investigation at some point in the future.

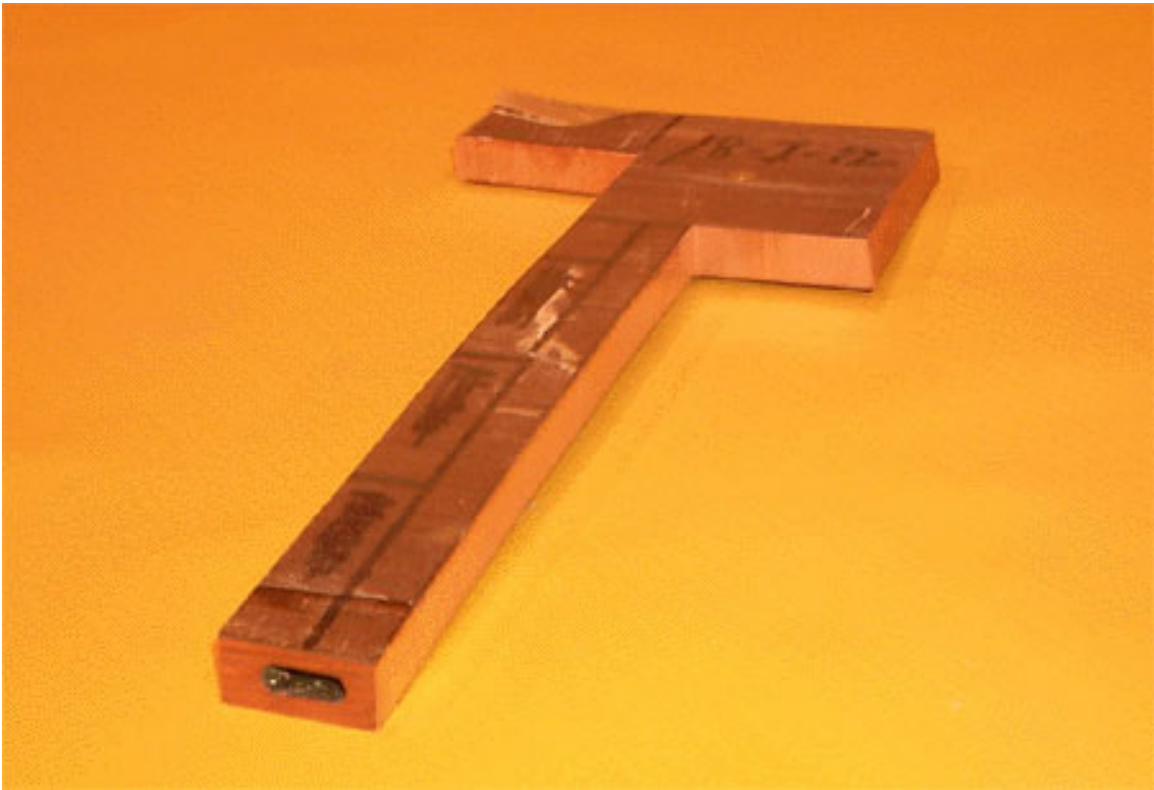
Figure 31 - Leftover turn following cutting of 6 Charpy and 3 tension coupons

While the Nitronic 33 material from the sidewall plates was readily accessible but difficult to machine, the OFHC copper was exactly opposite. Working with the 44-turn bonded copper bundles was fairly cumbersome and time consuming. Machining the copper was relatively easy once it could be extracted. First, the two 22-turn pancakes had to be separated from each other. This was usually accomplished by setting the overall bundle in a sling to orient it for a single saw cut in the RESA building. Once two pancakes were separated, the next task was to separate the 22-turns in each of the pancakes from each other. This required the removal of the potting compound and overwrap materials from the pancakes, to be followed by the turn-to-turn separation of the copper. Several randomly selected turns of copper were chosen beforehand to be extracted for cutting into the tension and Charpy test coupons. Figure 28 shows a typical turn of copper with portions of insulation tape still attached to the turn. Each one of these selected turns would then be cut in such a way as to yield three coupons in both the axial and transverse directions for impact testing (six impact test coupons from each selected turn). Figure 29 shows a typical Charpy coupon prior to machining. This was accompanied by cutting three tension coupons (Figure 30) from each selected turn along the axial (poloidal) direction of the turn. Acceptable tension specimens in the transverse direction were not possible because of the presence of the extruded cooling channel in the turn. Figure 31 shows the leftover turn following the cutting of all necessary coupons from it.

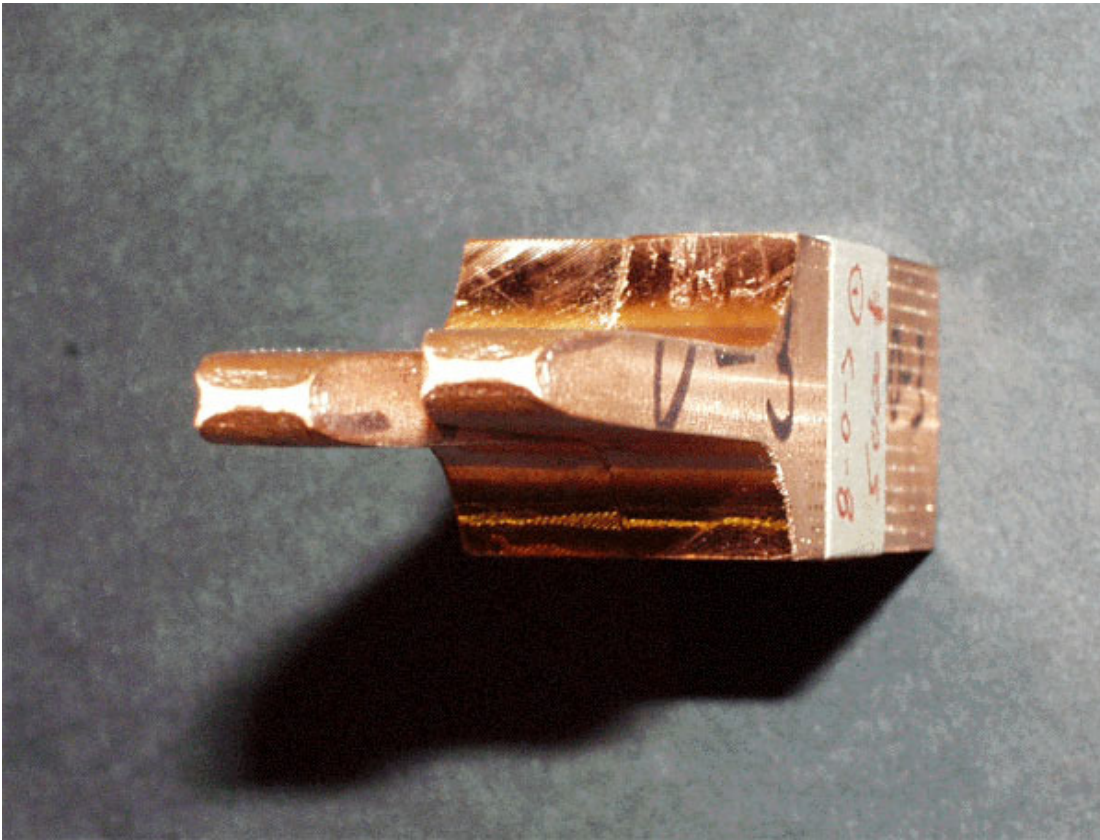
Figure 40 - Typical Failure Surface of Copper Tensile Specimen

brazed joints themselves were designed to be stronger than the local copper implying that the failures in the relevant tension specimens would be in the copper and not the joints. With one exception, these specimens all failed in the copper. The mean yield stress for this group of specimens was 13.8 ksi and the mean ultimate stress was 30.5 ksi. These values correspond with reference values for copper that is almost fully annealed. Similar consistency with reference values was exhibited for elongations of approximately 50 percent and reduction of areas of over 80 percent. Figure 41 compares two tension samples - one hardened and the other almost fully annealed. The most obvious difference between them is that the ductility in the annealed specimen (with the brazed V-joint clearly visible) grew nearly an inch longer in the tension test prior to failure. The one specimen that did fail in the braze joint showed far less ductility by yielding at 13.8 ksi, but failing at only 26.6 ksi. Elongation was 25 percent, half the annealed values, while the reduction in area was also lower at 76.5 percent.

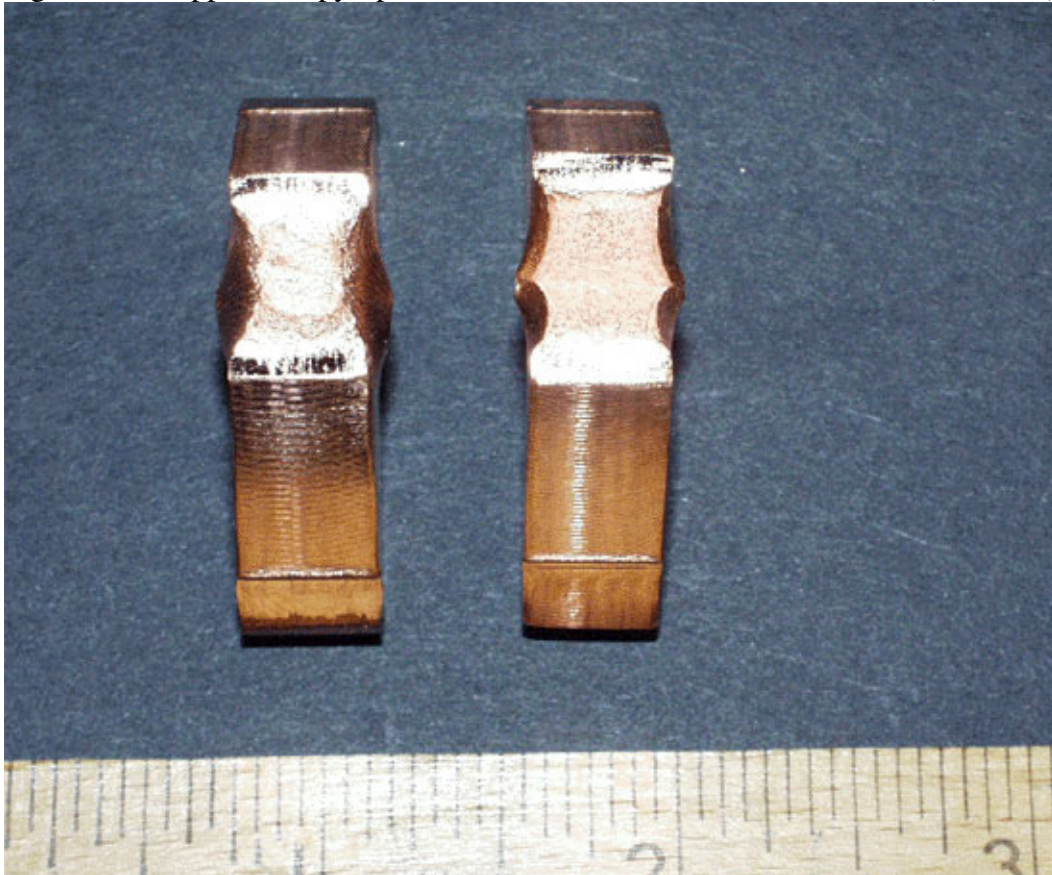
Figure 43 - Copper Charpy Impact Fracture Faces - Hardened (left) vs. Annealed

Results for the Charpy V-notch impact tests ranged from 137-156 ft-lbs of energy absorbed for the hardened copper and ranged from 66-119 ft-lbs for the annealed copper. This means that the impact resistance of the hardened copper is greater than that for the annealed copper and should be evident upon viewing the tested samples. Figure 42 shows three Charpy specimens - an untested Charpy specimen, a hardened test sample and an annealed test sample (from left to right). The major difference visible in this figure is that the break in the annealed sample runs much deeper than the hardened sample, indicative of the hardened sample's ability to absorb more impact energy. Figure 43 is a close-up view of the break faces. The annealed sample (on the right) has a larger, cleaner and smoother fracture surface, indicative of lower impact resistance than the hardened specimen, which has a more pronounced hourglass shape and more striated fracture surface.

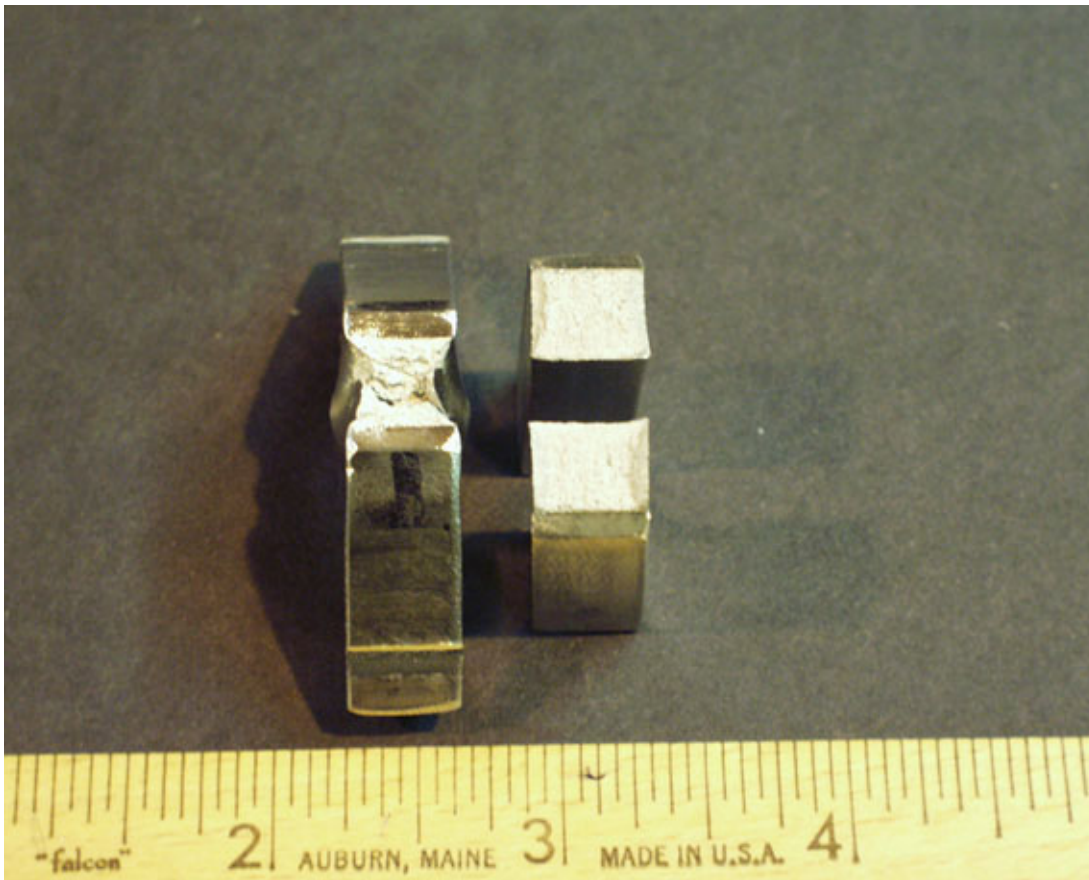
Figure 46 - Nitronic 33 Charpy Impact Fracture Faces - R.T. (left) vs. LN2

Charpy V-notch impact results in the literature vary from 232-300+ ft-lbs at room temperature for Nitronic 33. The first few Nitronic Charpy tests conducted at room temperature were consistently greater than 290 ft-lbs. Since the Tinius-Olson impact test machine is a 300 ft-lb device, accurate performance and results could not be assured under these conditions. It was decided to test the majority of the samples at liquid nitrogen (77K). The literature indicates a minimum 30 ft-lb impact strength for Nitronic 33 at 77K. Test results ranged from 34-51 ft-lbs, exceeding the established minimum for impact strength. These results can be extrapolated and coupled with the few tests performed at room temperature resulting in a conclusion that all Charpy specimens met the minimum established impact resistance requirements. Charpy tests results were isotropic. Figure 45 compares Charpy specimens at room temperature (left) and LN2 (right). Lower temperature makes the metal more brittle, thereby reducing its impact resistance. Due to its ductility, the room temperature sample readily absorbed 300 ft-lbs of energy, while the LN2 sample broke at approximately 40 ft-lbs. Figure 46 compares the fracture faces of these two samples. The room temperature sample (left) has a rough, striated face indicative of high impact resistance. The LN2 sample (right) has a smooth, clean fracture surface with slight shear lips at the edges, which is normal.

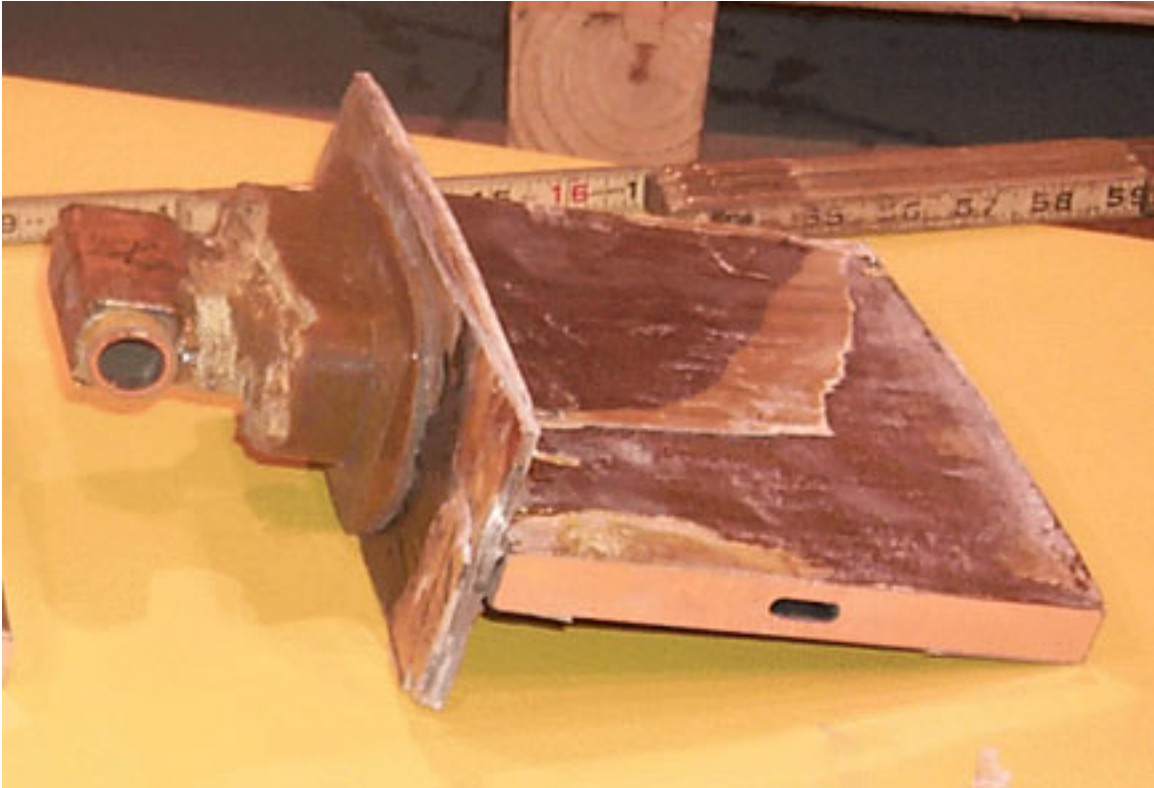
Figure 50 - Extracted Water Fitting Section From TF #3 For Metallurgical Examination

area, the copper transitions back to hard (32 ksi yield) copper. The copper plate is then wound into the coil turn, and buckling in the annealed crosswise channel can easily occur as the metal acts like a hinge.

The other two tested fittings also had this same buckled phenomenon, however, the crosswise cooling channel was centered better in those turns, avoiding a thin-walled thru-crack. It is not hard to imagine that out of the 280 water fittings on the TFTR TF coils, several others may have had leaks where the annealed copper crosswise channel was not properly centered in the turn.
